Manhole Inspection Summary

Manhole # S11M__014MH

Insp Date: **4/8/08 9:17 AM**

Location Address: **3120 S. Mt Olive St**

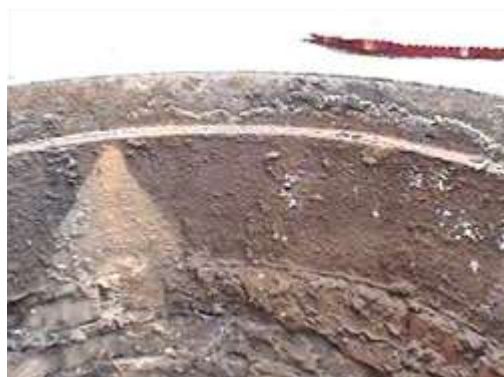
Defect 3

Frame Offset: **0** (in.) Condition: ☐ Sound ☐ Cracked ☒ **Leaks**

Infiltration: ☐ None ☐ Joint ☐ Cracks ☐ Mortar ☐ Roots ☒ **Wall**

frame and chimney infiltration

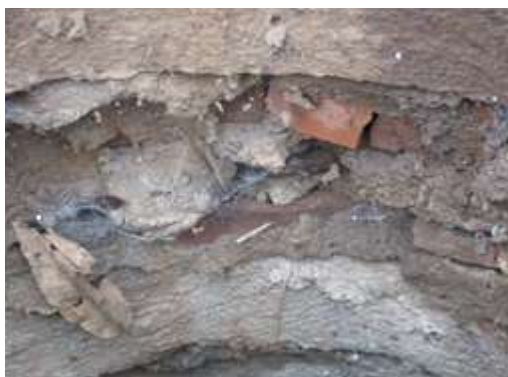
Defect 2

Condition: ☐ Sound ☐ Cracked ☐ Root Intrusion ☐ Loose Brick ☒ **Deteriorated**

chimney deteriorated

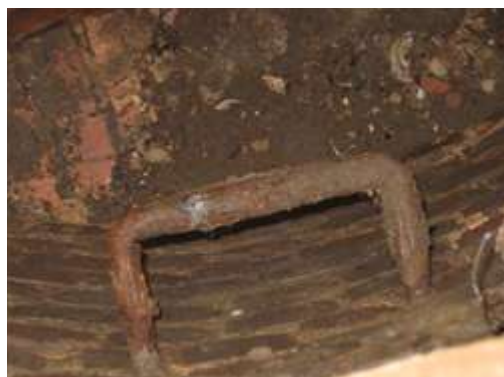
Defect 1

Corroded steps

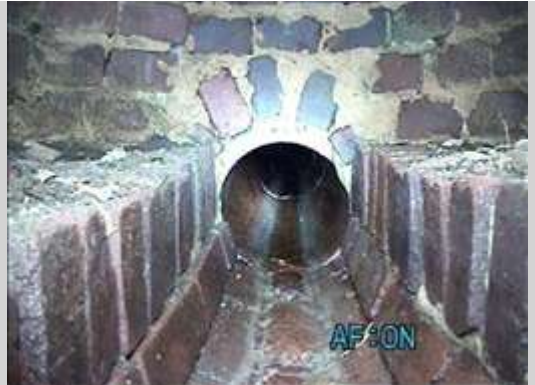
12 O'Clock Outflow

8 in. Circular Gravity Sewer
Pipe Out @ 12 O'Clock

Pipe Height: **8.4** (in.) Rod and Bar (Angled)
Pipe Material: **Clay** ☐ Pipe Lined
Invert Depth: **6.95** (ft.) Flow Characteristics: **Fast**
Deposits: ☒ None ☐ Mud ☐ Sludge ☐ Debris ☐ Grease
Silt Depth: **0** (in.) Deposits Extent:
Infiltration: **None** Pipe Seal Cond: **Sound**

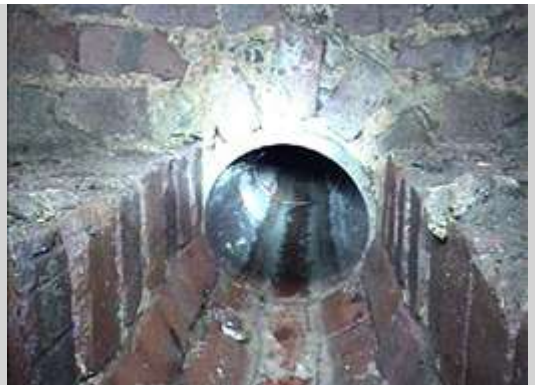
6 O'Clock Inflow

8 in. Circular Gravity Sewer
Pipe In @ 6 O'Clock

Pipe Height: **8.4** (in.) Rod and Bar (Angled)
Pipe Material: **Clay** ☐ Pipe Lined
Invert Depth: **6.85** (ft.) Flow Characteristics: **Fast**
Deposits: ☒ None ☐ Mud ☐ Sludge ☐ Debris ☐ Grease
Silt Depth: **0** (in.) Deposits Extent:
Infiltration: **None** Pipe Seal Cond: **Sound**
